Kenny Residential Development
Gungahlin Blocks 722, 668, 699 & 792

–Cultural Heritage Assessment and Statement of Heritage Effects.

Report Prepared for Environment, Planning and Sustainable Development

26/07/2022

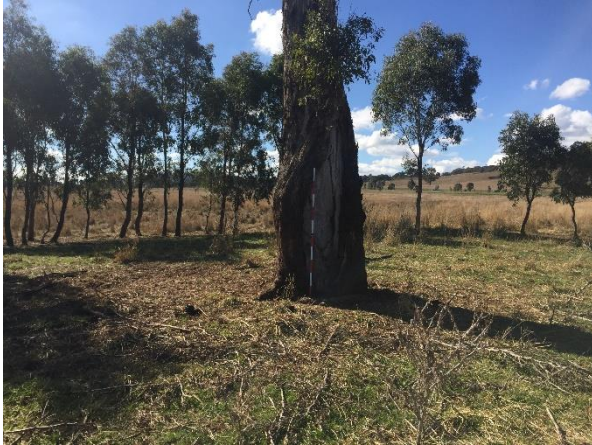
Plate 56. Site of KH5 'Ring Barked Tree' in SU5 (North)

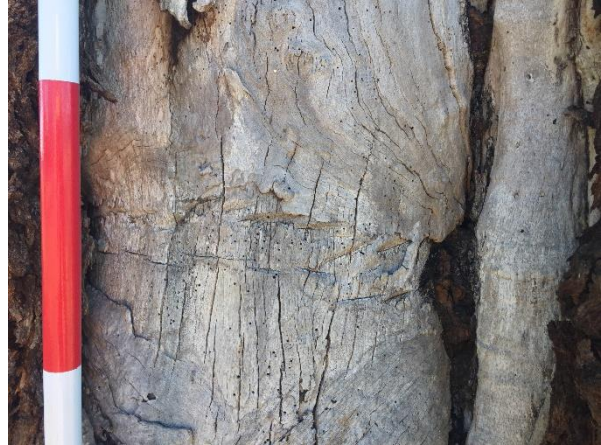
Plate 57. Closeup of KH5 tree, with cut marks clearly visible (North)

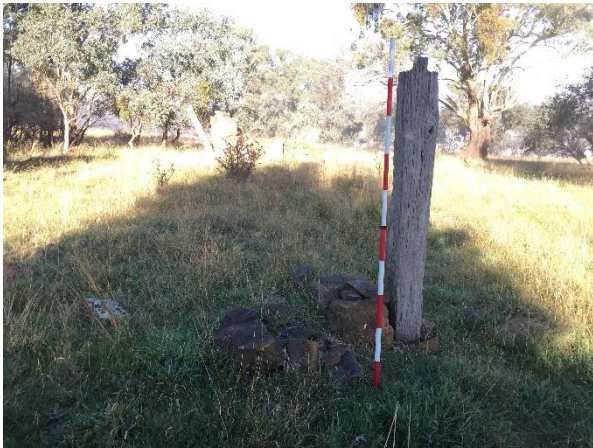
Plate 58. Timber support post and remnant stone foundations at William Ginn ruin site (South)

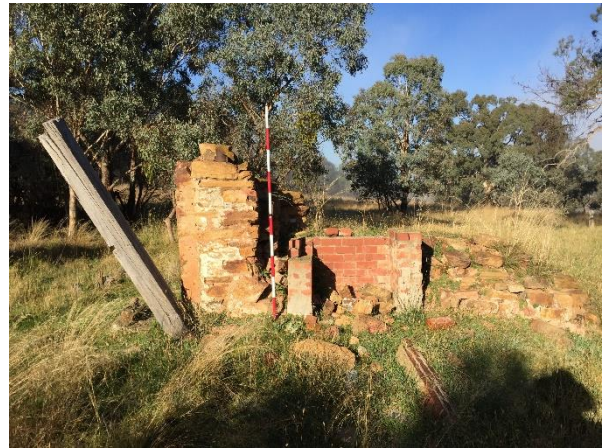
During the current survey the site was revisited, with its current condition shown from Plates 58 to 65. The walls of the fireplace have been repaired using 1920's Canberra bricks. The location of these ruins was originally recorded further West, however the GDA94 MGA55 coordinate at the centre of these ruins at 698389.6100669 is outside the Project Area. As a result, no impacts will occur from the development.

Plate 59. Timber support post leaning East, with partial stone wall and fireplace (South)

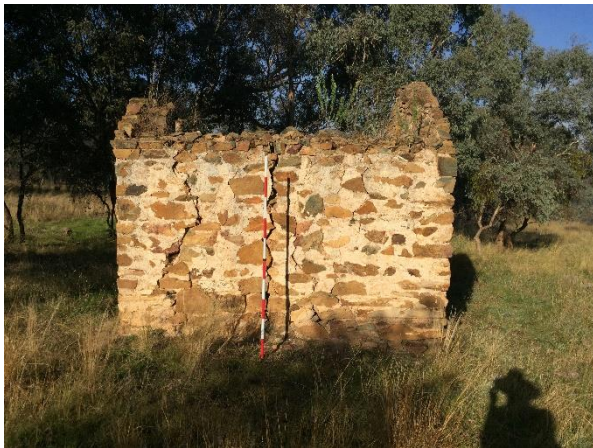
Plate 60. North wall of William Ginn site outbuilding (South)

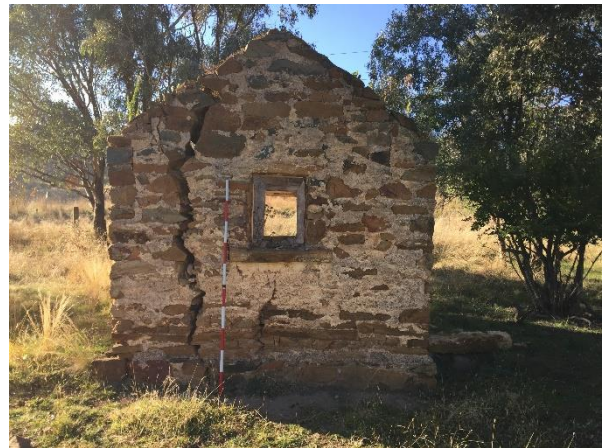
Plate 61. West wall with window and a large crack running the height of the wall of outbuilding (East)

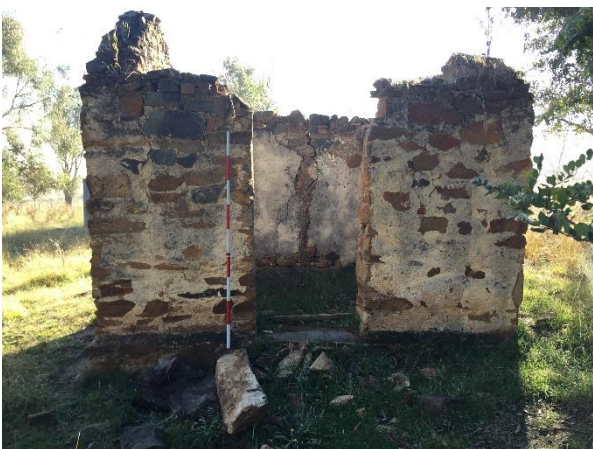
Plate 62. South entrance with collapsed lintel of outbuilding (North)

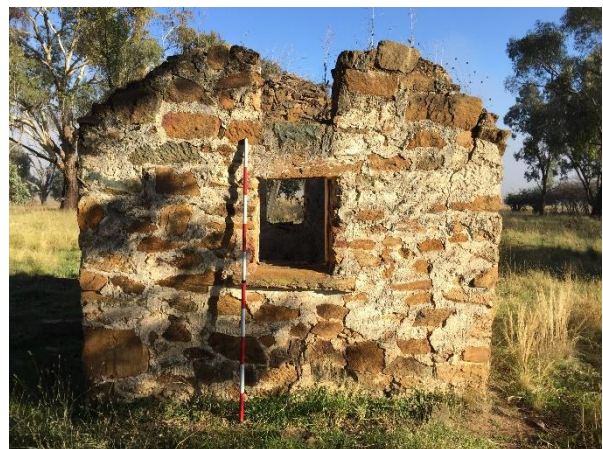
Plate 63. East wall with window and square shape missing at the top of the gable of outbuilding (West)

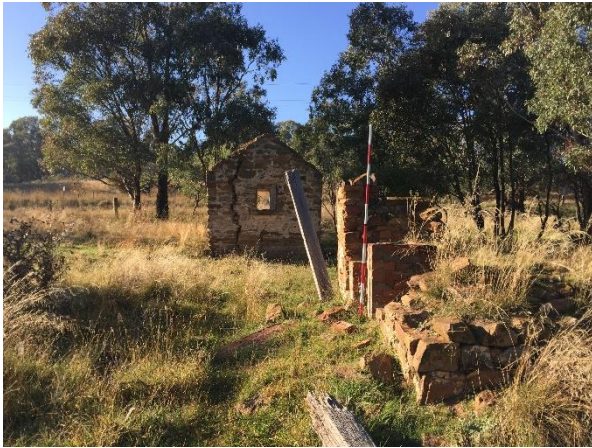
Plate 64. View from west overlooking the fireplace and outbuilding (West)

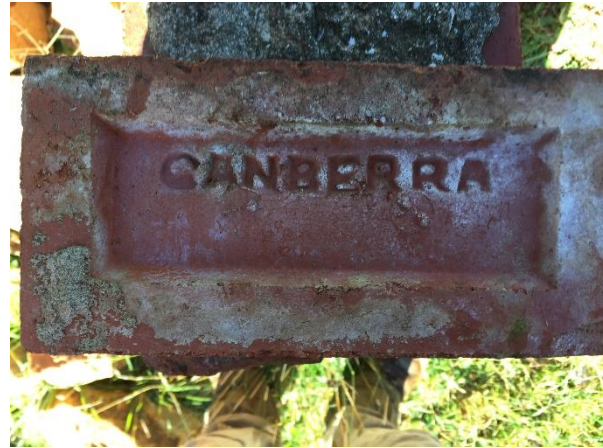
Plate 65. Stamped 'CANBERRA' red brick with two symbols of a bone within a circle stamped under the 'AN' and 'RR'

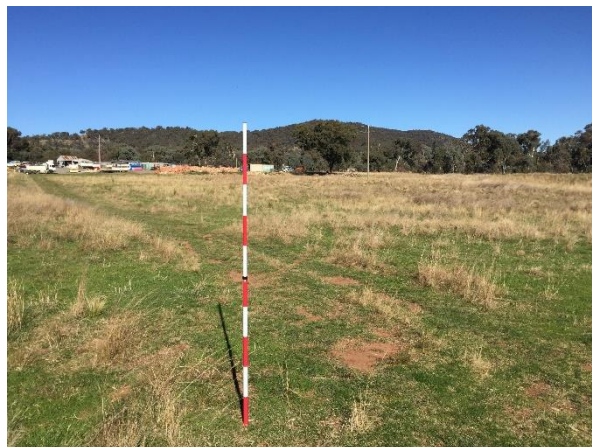
The area of the historical bottle dump is located within close proximity to the existing business along the Federal Highway to the Southeast of the Project Area. The site is assessed as holding low significance and no heritage constraints apply to this location.

Plate 66. Exposed vehicle track with the area of the historical Bottle Dump in the Background of SU3 (Southeast)
